Errata
MSP430F67791 Microcontroller

ABSTRACT

This document describes the known exceptions to the functional specifications (advisories).

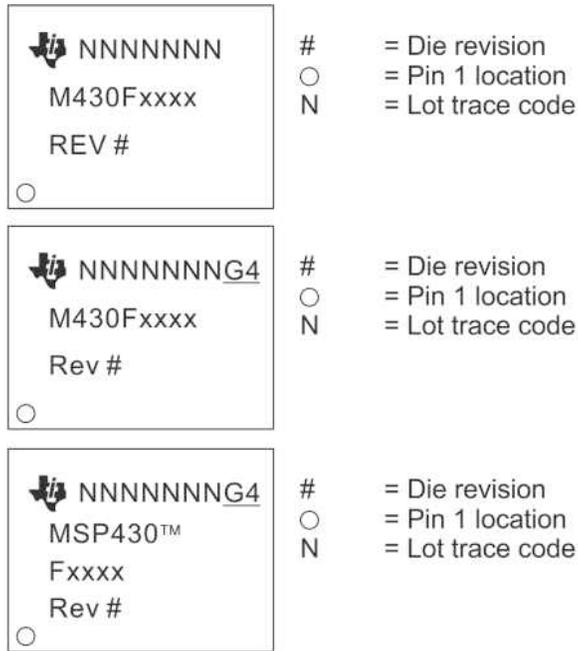
PZ100

LQFP (PZ) 100 Pin

NOTE: Package marking with "TM" applies only to devices released after 2011.
