/ 🕰 Topics (https://groups.io/g/HP-Agilent-Keysight-equipment/topics?p=recentpostdate/sticky,,,20,2,0,94160120) / 🔩 E4402B RF Section CLIP required

Morning, would anyone be able to let me have a copy of a good quality scan of the CLIP for the RF section in an Agilent E4402B analyser?

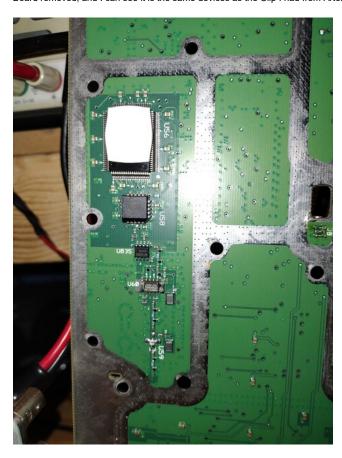
I watched the video again, and I can see the IC in question is on the back of the PCB, so I need to remove it fully from the chassis to check. Board removed, and I can see it is the same devices as the Clip I had from Artek,here is a photo of the divider section on the back of the PCB.

The fact that several people have had this IC go faulty and show similar symptoms, I am going to try and get hold of one and replace it.

Look at the HMC365S8GE from Analog devices

Do take care when removing the old chip as it has an exposed pad underneath I removed mine with hot air rework and a hotplate below to pre heat the board

Yes, I used hot air for both removal and application (with solder paste). Don't forget to remove pins 2 & 6!

I was also concerned about the supply rail being too high. (6V?) To be safe, I removed the ferrite and replaced with a diode for a 0.6V voltage drop.

As far as removal......cut the leads off the old part, twist off the part (it is soldered to the ground plane as a heat sink). When installing I used a little low temperature solder on the heat sink area first which helps the regular solder flow quickly. This way you do not overheat the whole board,

and as pointed out....remove pins 2 & 6.
